Village of  
**LA GRANGE**

Capital  
Improvement  
Plan

August 31, 2011

# Village of La Grange, Illinois Capital Improvement Plan

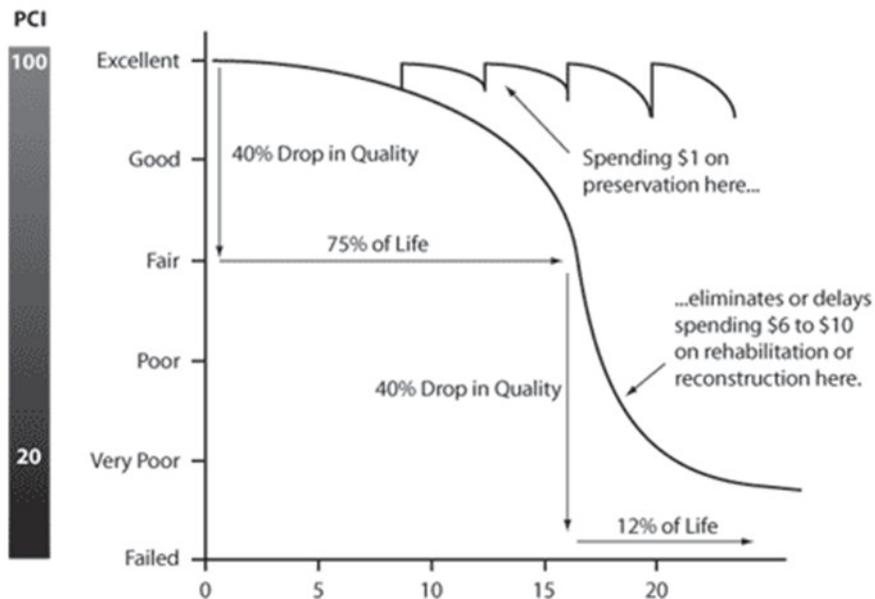
Figure 2 Pavement Life Cycle

Most pavements tend to follow a generalized pavement condition life cycle as seen in Figure 1.

If maintenance and repair is performed during the early stages of deterioration, before the sharp decline in pavement condition, a significant cost savings can be shown. Waiting to repair the road past this pivot point, referred to as the critical PCI, can also require long periods of closure or detours.

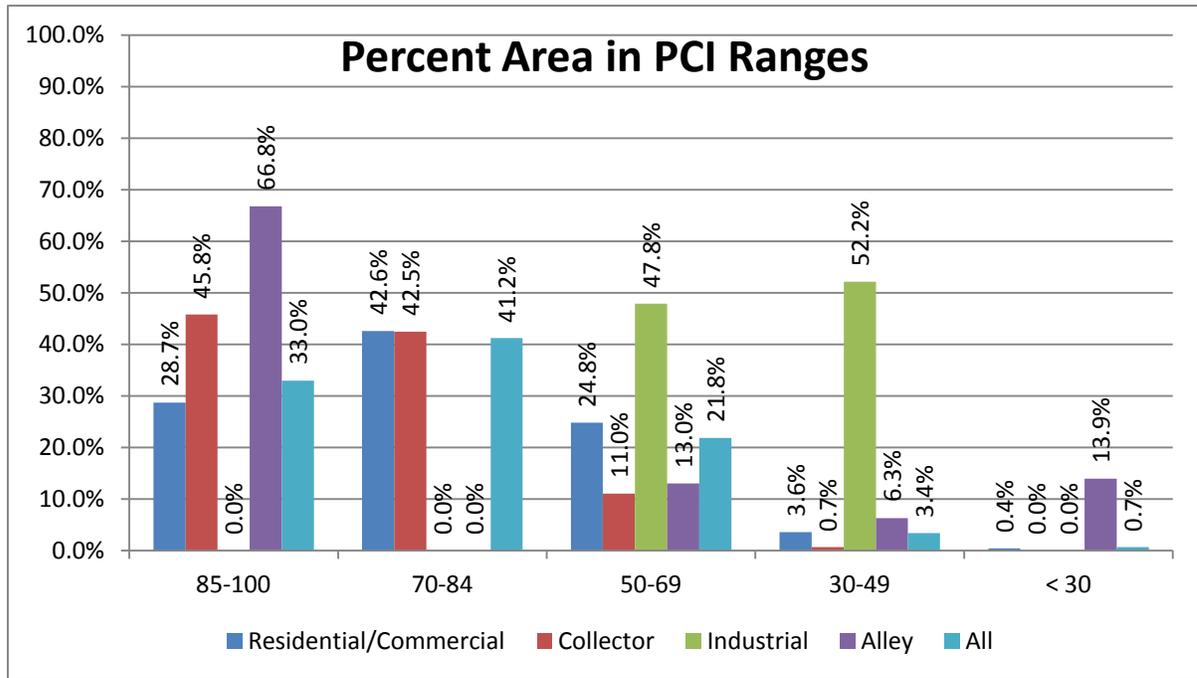
Figure 3 Percent Area in PCI Ranges

The Village's overall street network is in relatively good condition as can be seen in Tables 2 and 3, and Figure 2. The vast majority of the Village's residential and commercial streets are in good to excellent condition. Appendix 3 provides the entire street network database of all the streets maintained by the Village, sorted by PCI condition. Appendix 4 provides the entire street network database sorted by street name in alphabetical order. These tables provide information such as pavement length, width, area, and total estimated cost (which includes construction and engineering costs) for repairs or maintenance in 2011.

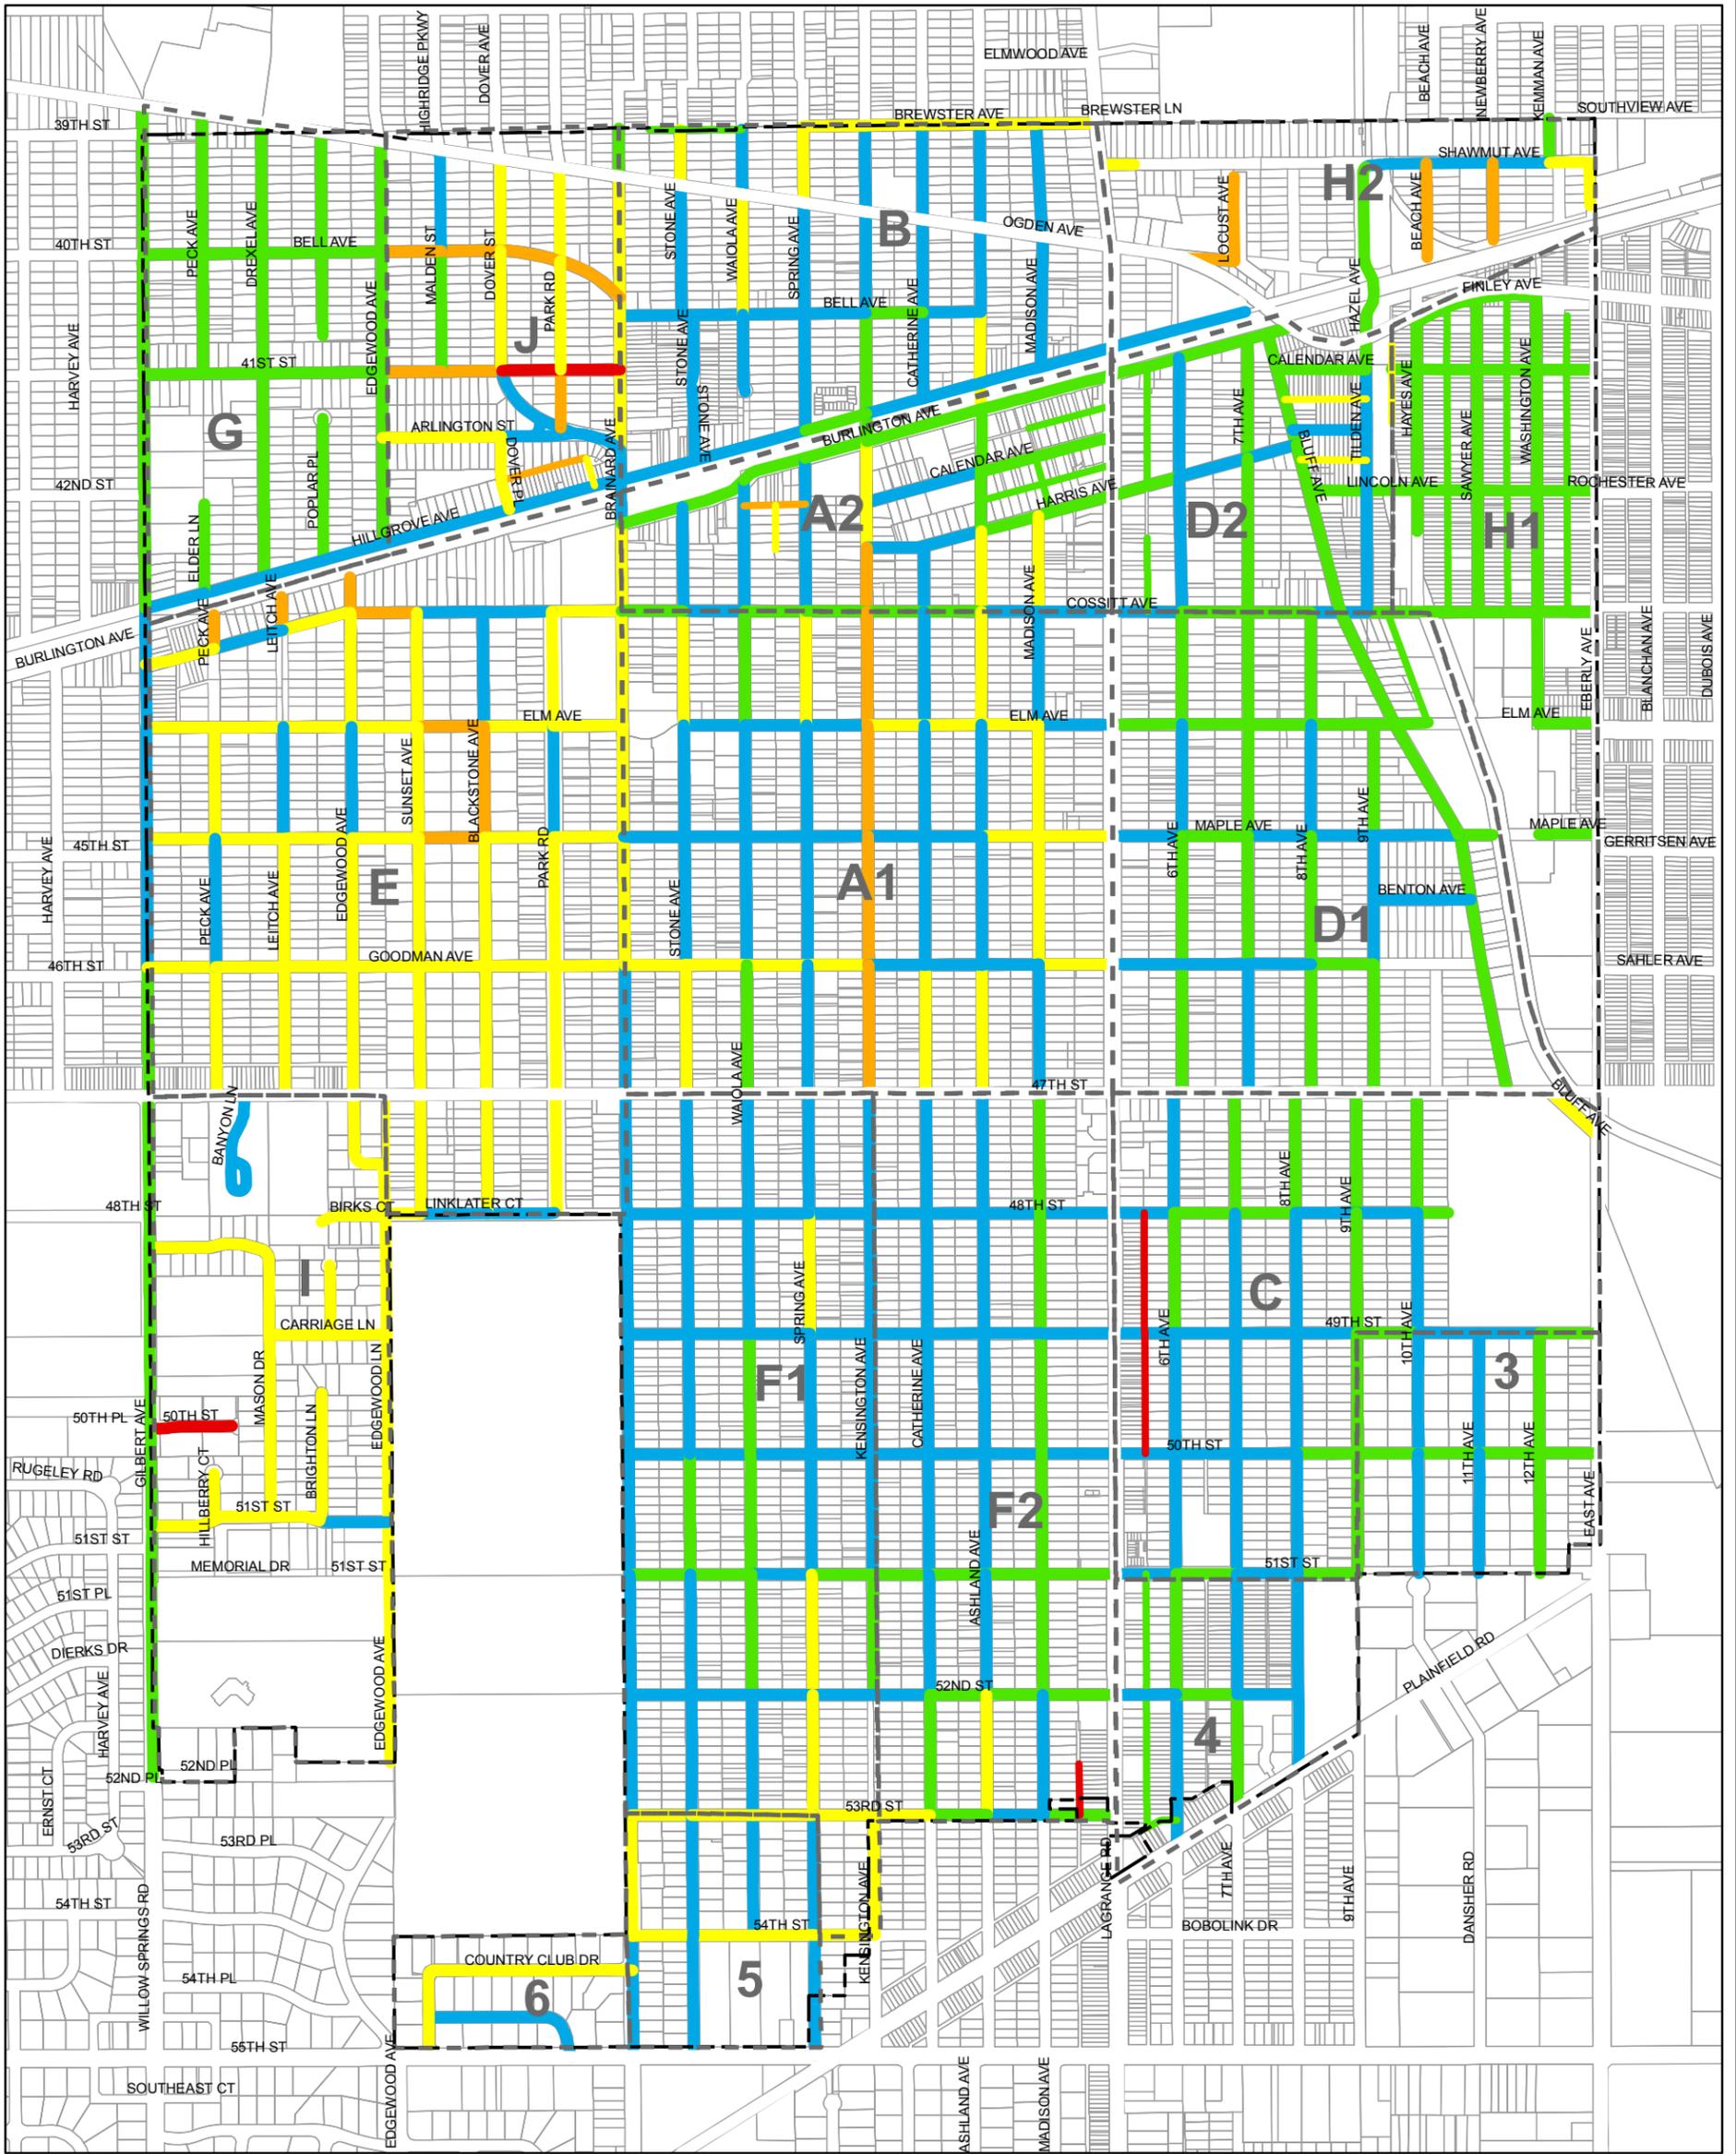
### VILLAGE OF LA GRANGE, ILLINOIS EXHIBIT 1 - PAVEMENT PCI RATING

- *PCI Index 30-49: Poor, Full-depth asphalt pavement removal and replacement (“Orange” color on Exhibit 1)*

- *PCI Index < 30; Failed, Reconstruction or Full-depth asphalt pavement removal and replacement (“Red” color on Exhibit 1)*

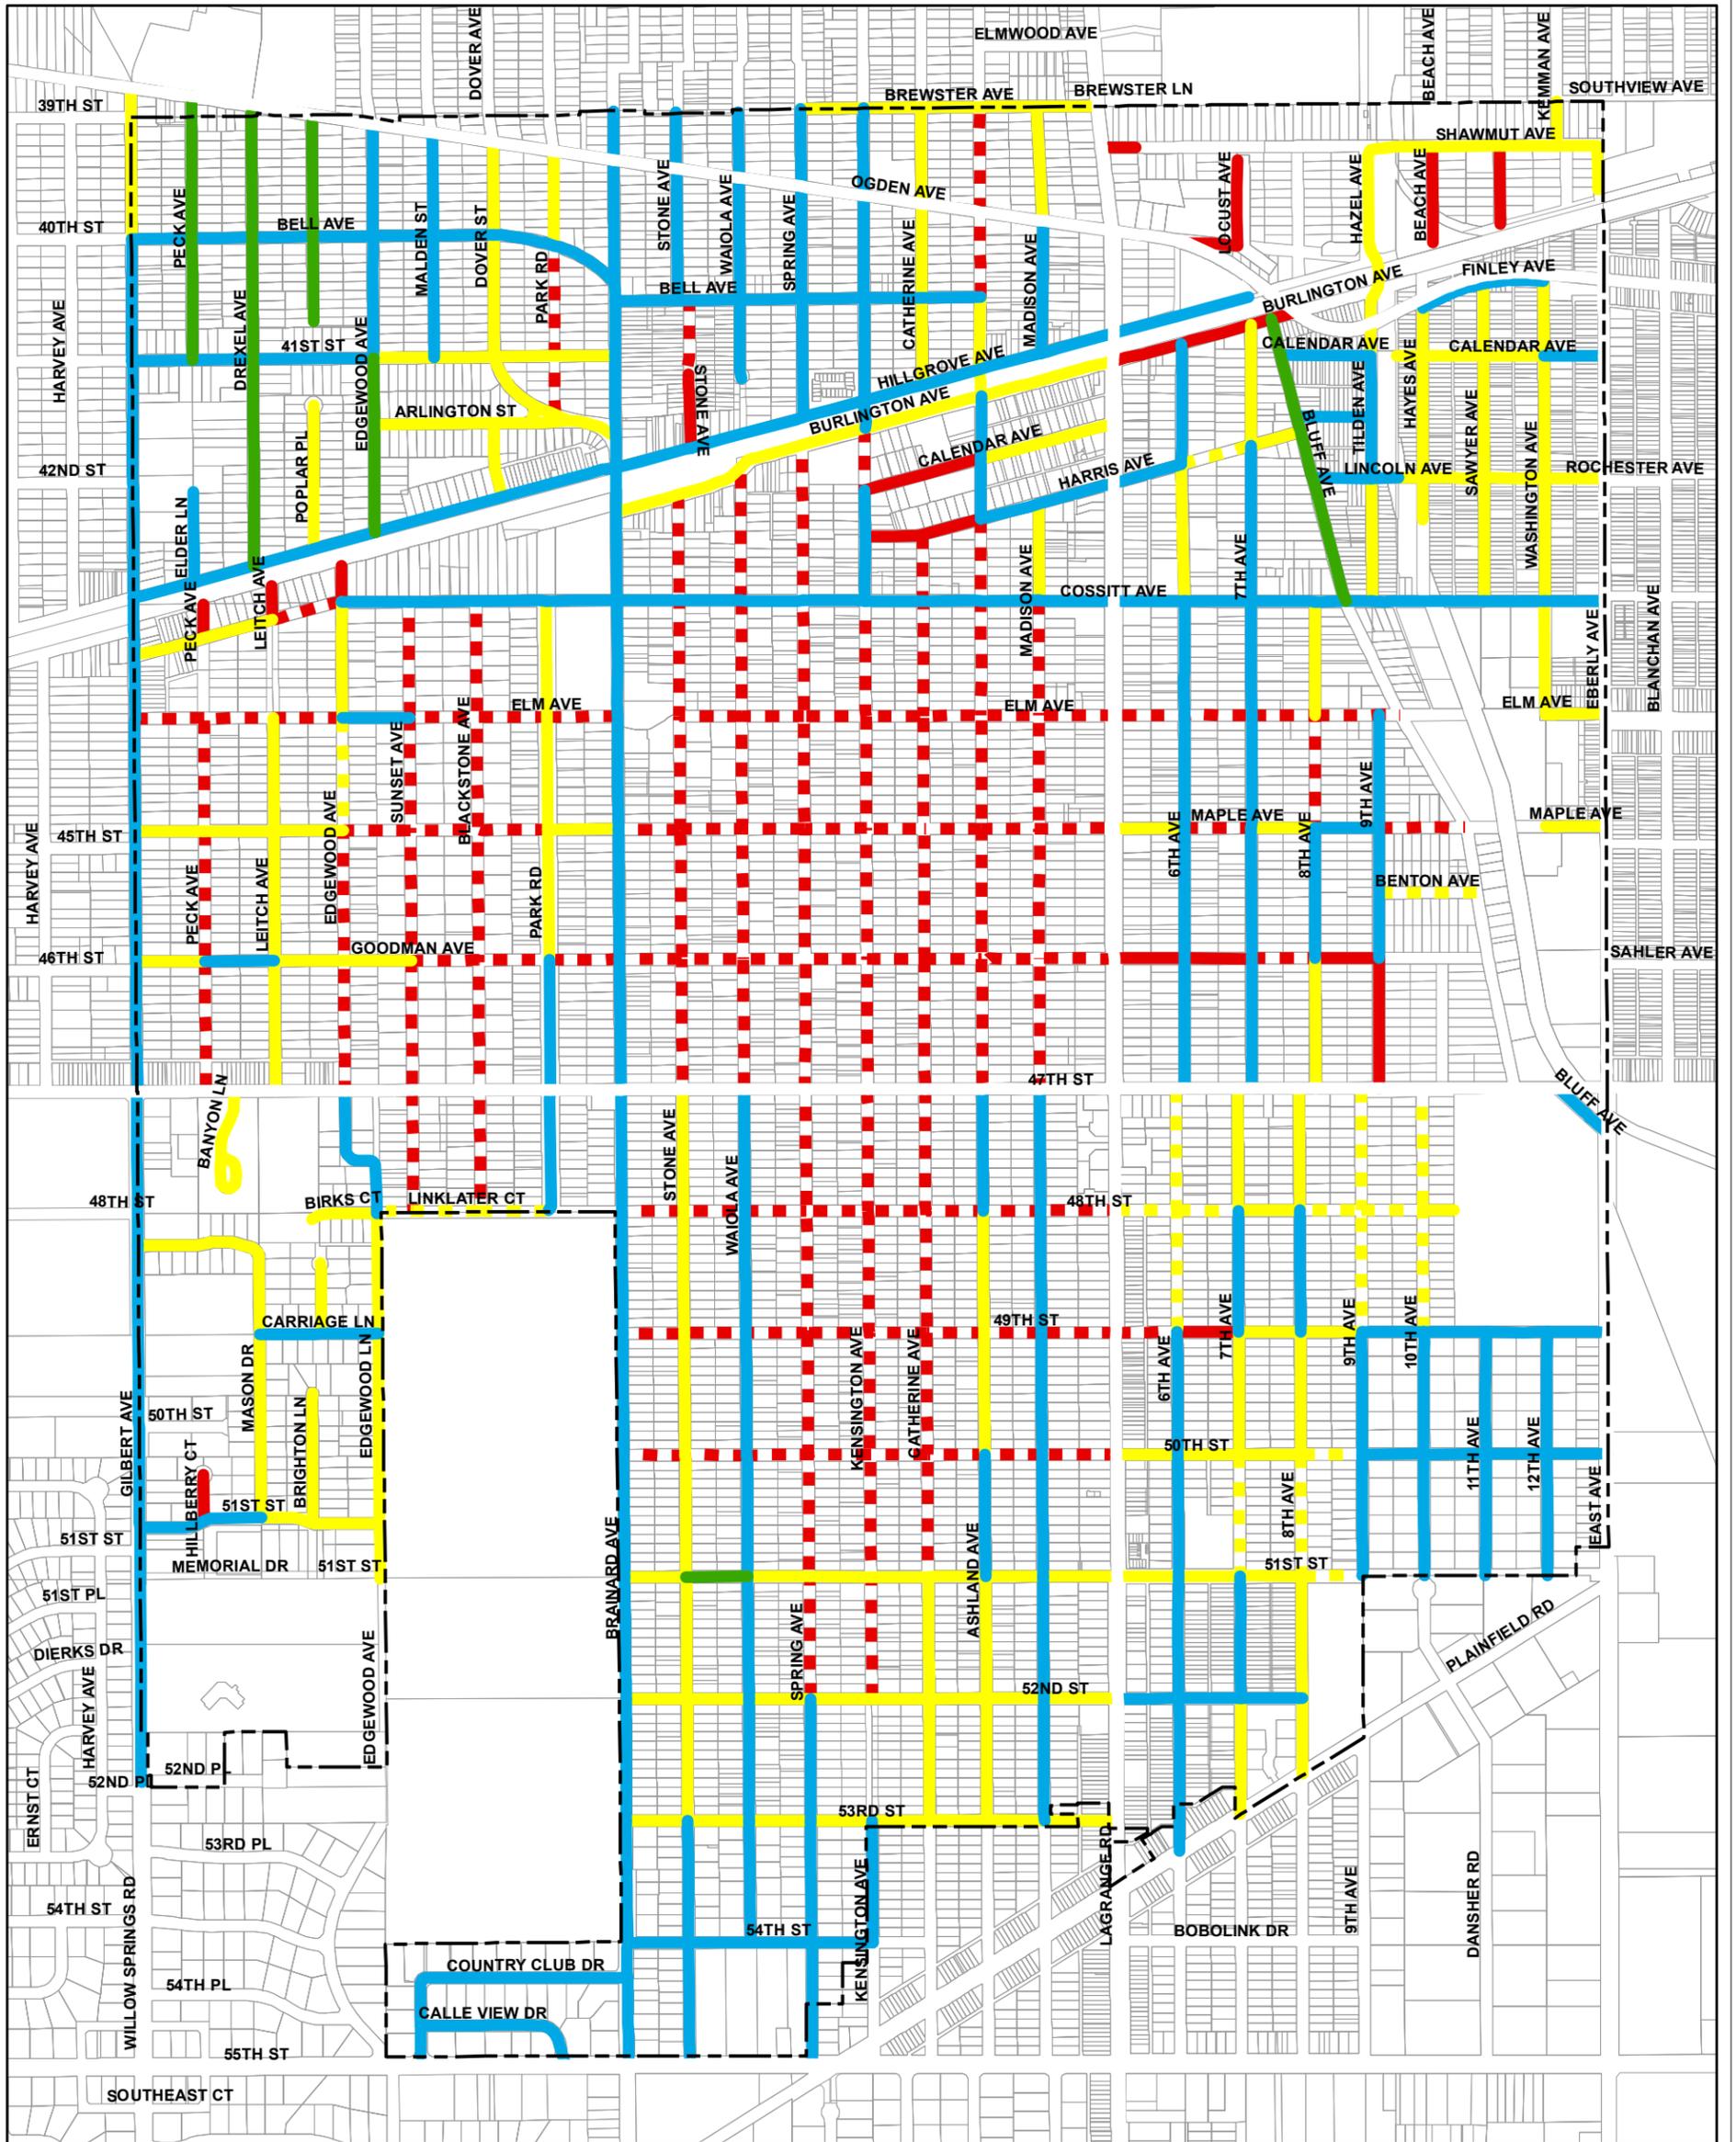
### VILLAGE OF LA GRANGE, ILLINOIS EXHIBIT 2 - CURB CONDITIONS

Although the Village’s pavement is in general in good condition, as seen in Table 3, more than half of the Village’s curb is in Fair to Poor condition. Curb in poor condition exhibits cracks, spalling, poor drainage, and excessive deterioration. Poor curb will translate to increased cost when rehabilitating the roadways.

Although most of the curb that is in poor condition happens to be overlaid, it does not appear that the overlay has caused the curb to be in poor condition, but rather the curb was likely in fair condition when overlaid and has not been updated since that time.

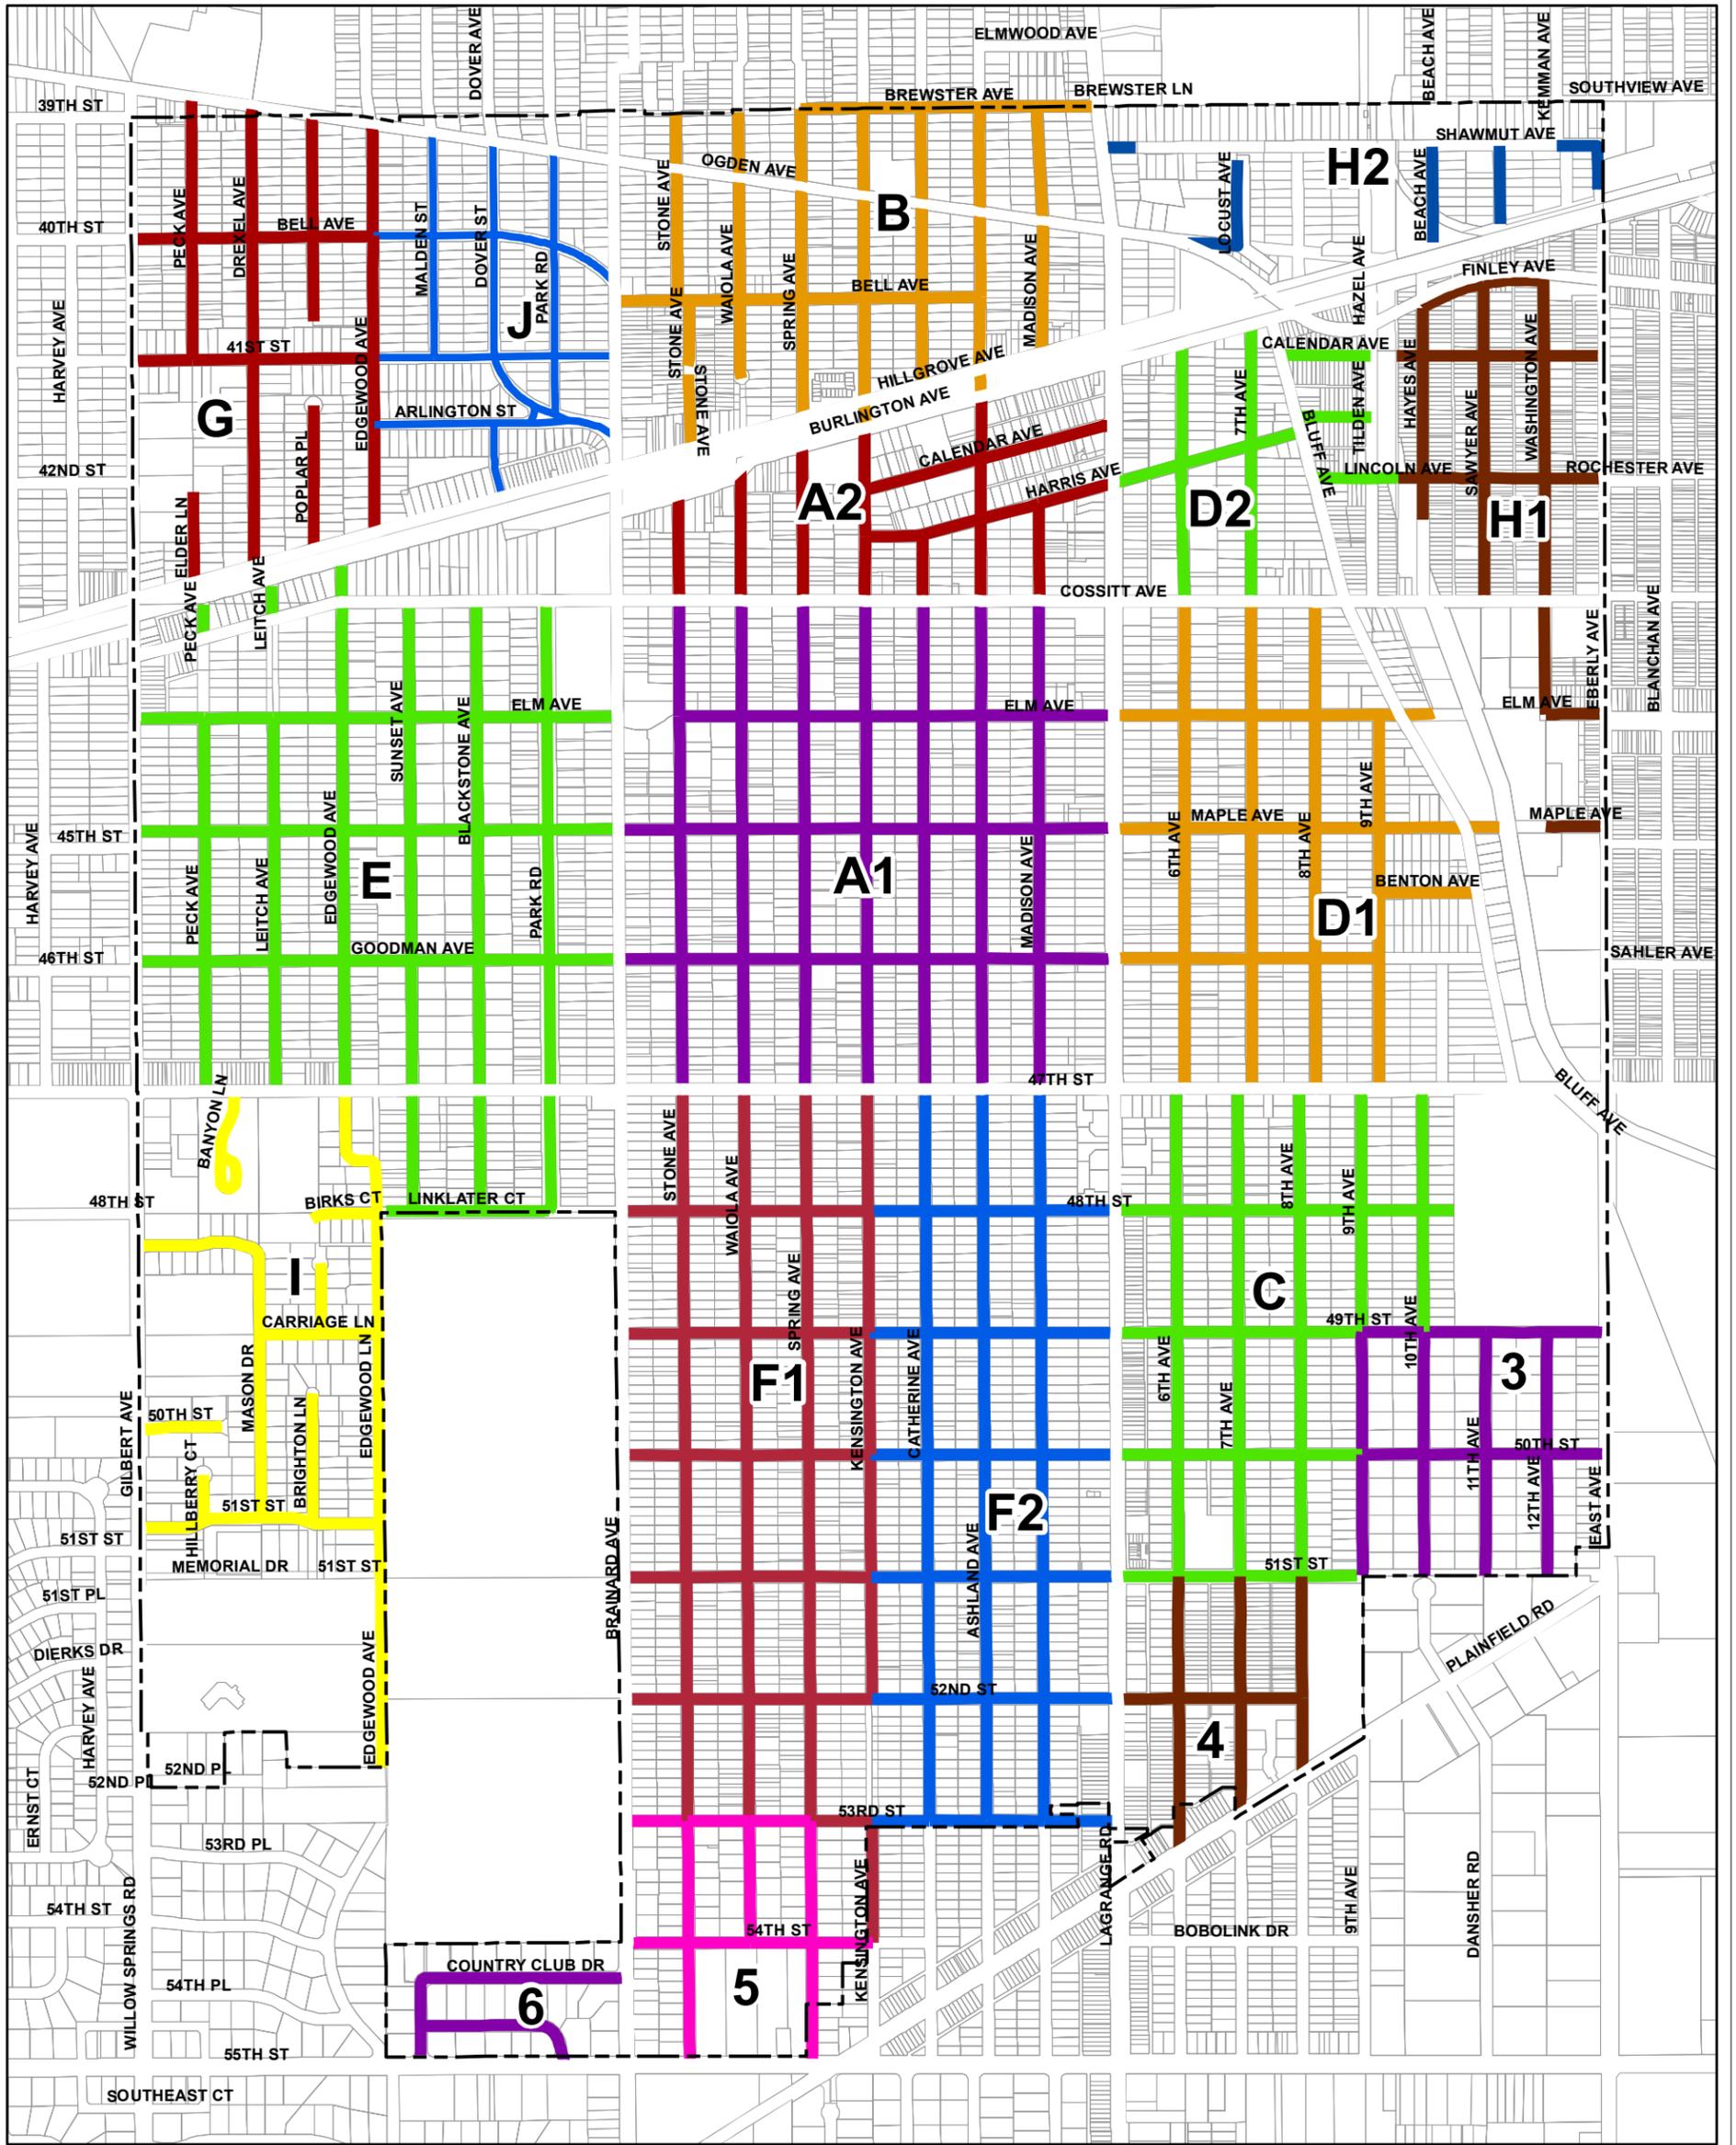
VILLAGE OF LA GRANGE, ILLINOIS  
EXHIBIT 3 - NEIGHBORHOOD PLANNING AREAS

The Village of La Grange has established Neighborhood Planning Areas, which it has utilized to improve the pavement network in groups in the past. This strategy has been beneficial for the Village as the neighborhood areas have deteriorated at approximately the same rate, although several streets are in significantly worse condition than its neighborhood area. Mobilization and traffic control costs during construction can also be reduced with this strategy. The neighborhood areas as provided by the Village were further refined to ensure that all pavement sections were included. The updated Neighborhood Planning areas can be seen in Exhibit 3.

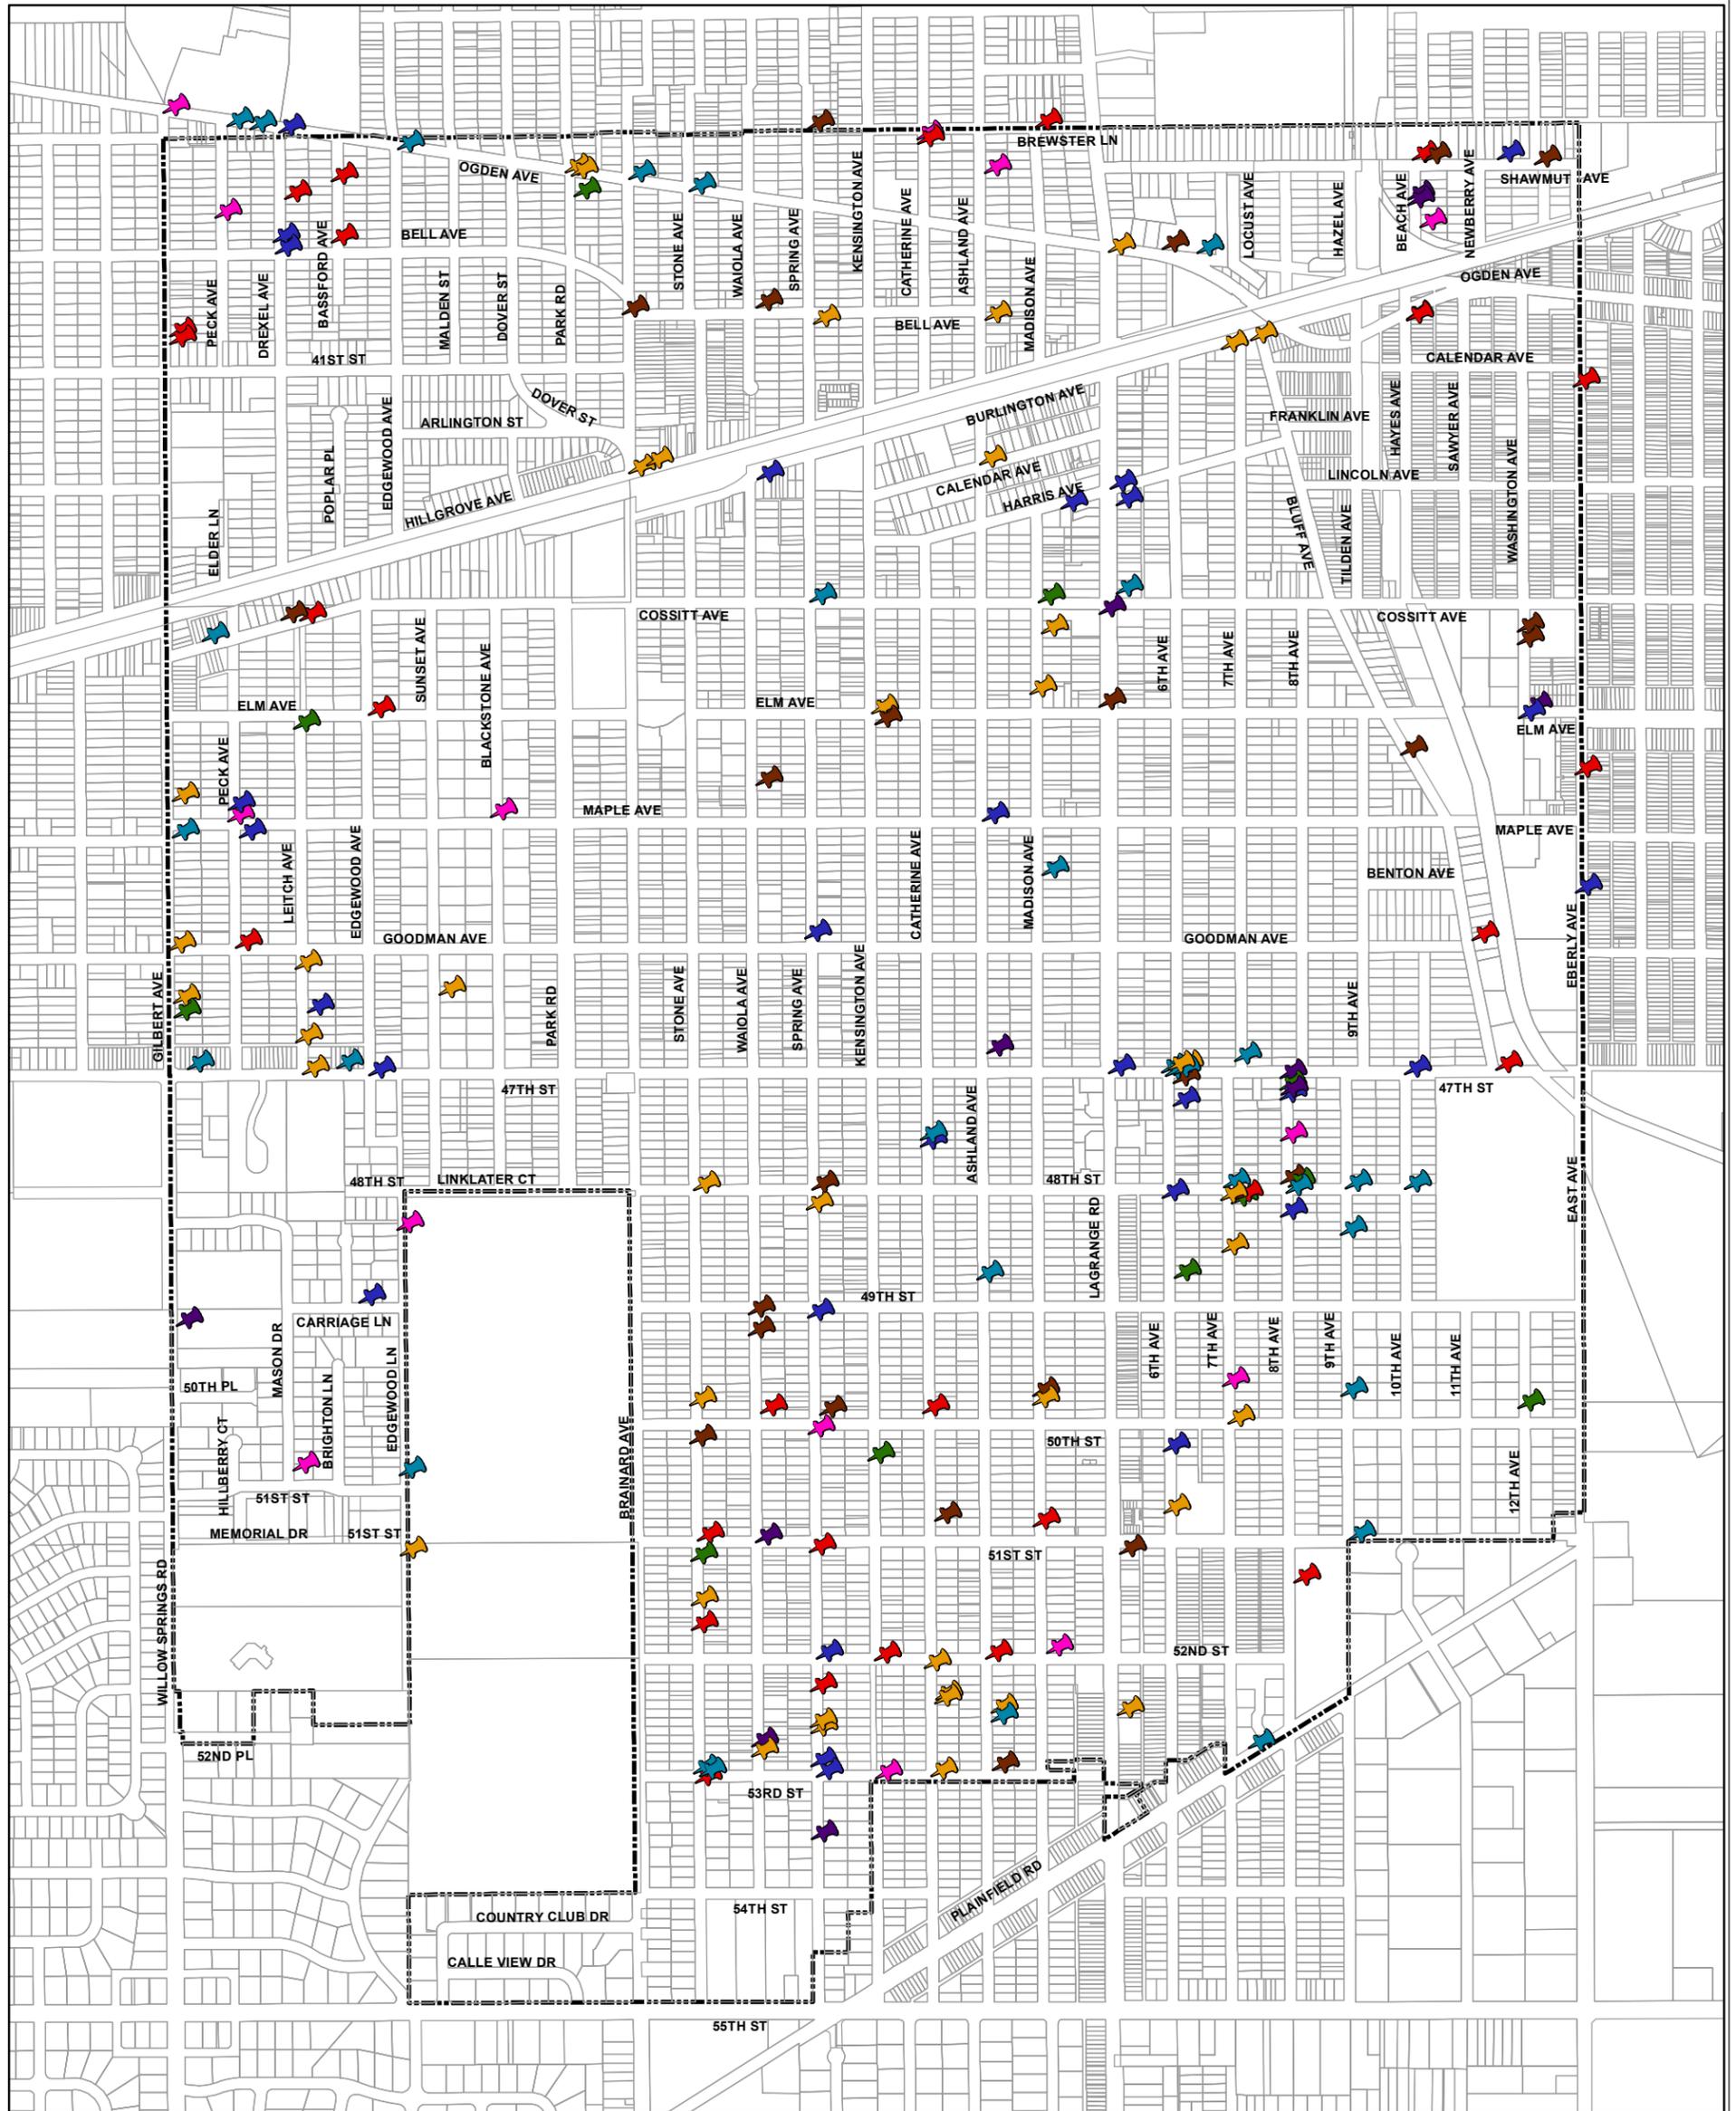
## VILLAGE OF LA GRANGE, ILLINOIS EXHIBIT 6 - WATER MAIN BREAKS

Exhibit 6 shows the location of all of the water main breaks that the Village has on record, from 2004 to present. In general, the Village’s water main system is in good operational condition. Areas C and H2 were noted to have the most water main breaks. It was also noted that the Village has a significant amount of old water mains, of which although are not currently problematic, should be considered for replacement when the adjacent street is replaced or resurfaced

Based upon water main break information presented in Exhibit 6, the next logical locations for water main replacement are Neighborhood Areas H2 and C. The total estimated cost to replace the water mains in Areas C and H2 is approximately \$2,600,000. Table 7 shows water main replacement costs on a per lineal foot and per size diameter basis. The costs in this table include 15% for design and construction engineering, and assume that replacement would be done concurrently with roadway improvements, thus do not include pavement patching.
